# Liquid Oxygen Cylinder Explosion

- Improper methods used to render scrap cylinder unserviceable
- Unsafe modifications to cylinder design

The incident described in the following presentation did not involve an Airgas company.

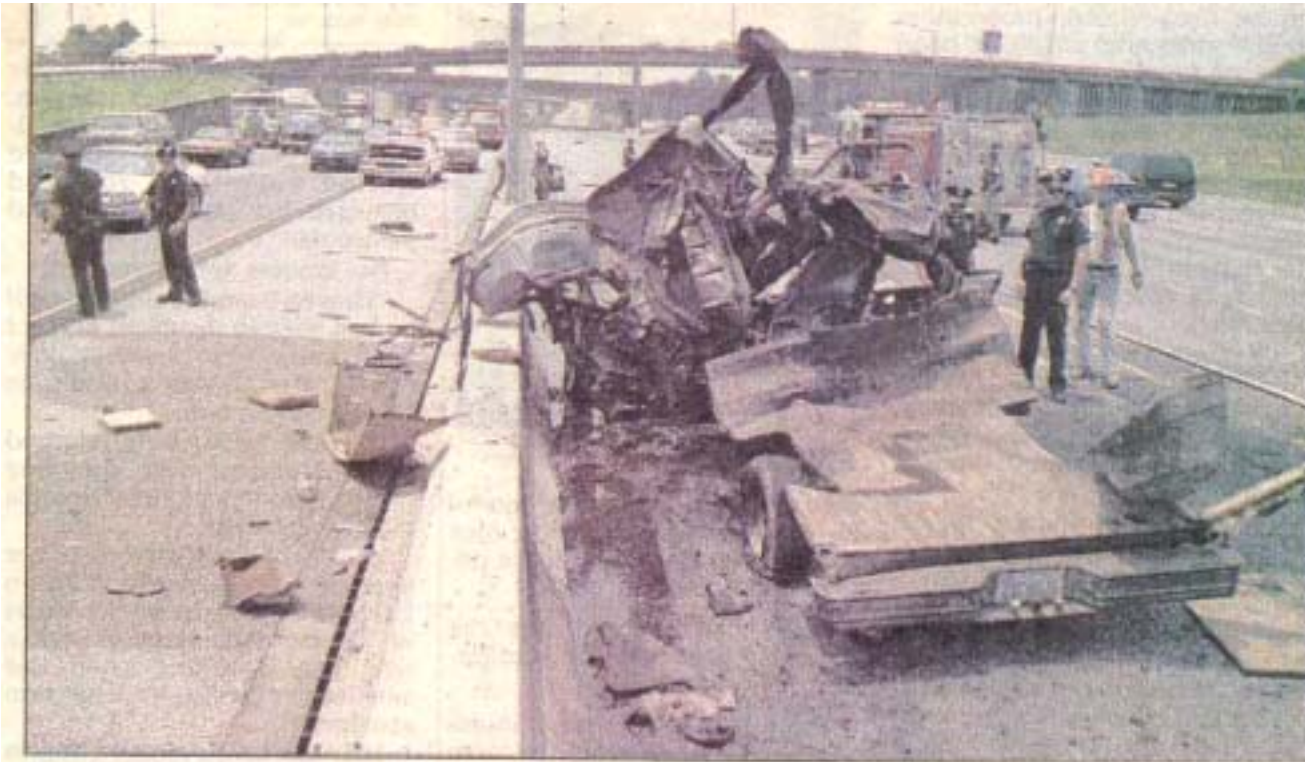
Note that the media reported the event as a Butane cylinder explosion

**Butane explosion on I-10  
hurts two, hits apartment**
